Beach Erosion and Sediment Processes Study, North East Marina, Erie County, Pennsylvania

Andrew Morang and Jeffrey Melton

June 2001

Final report

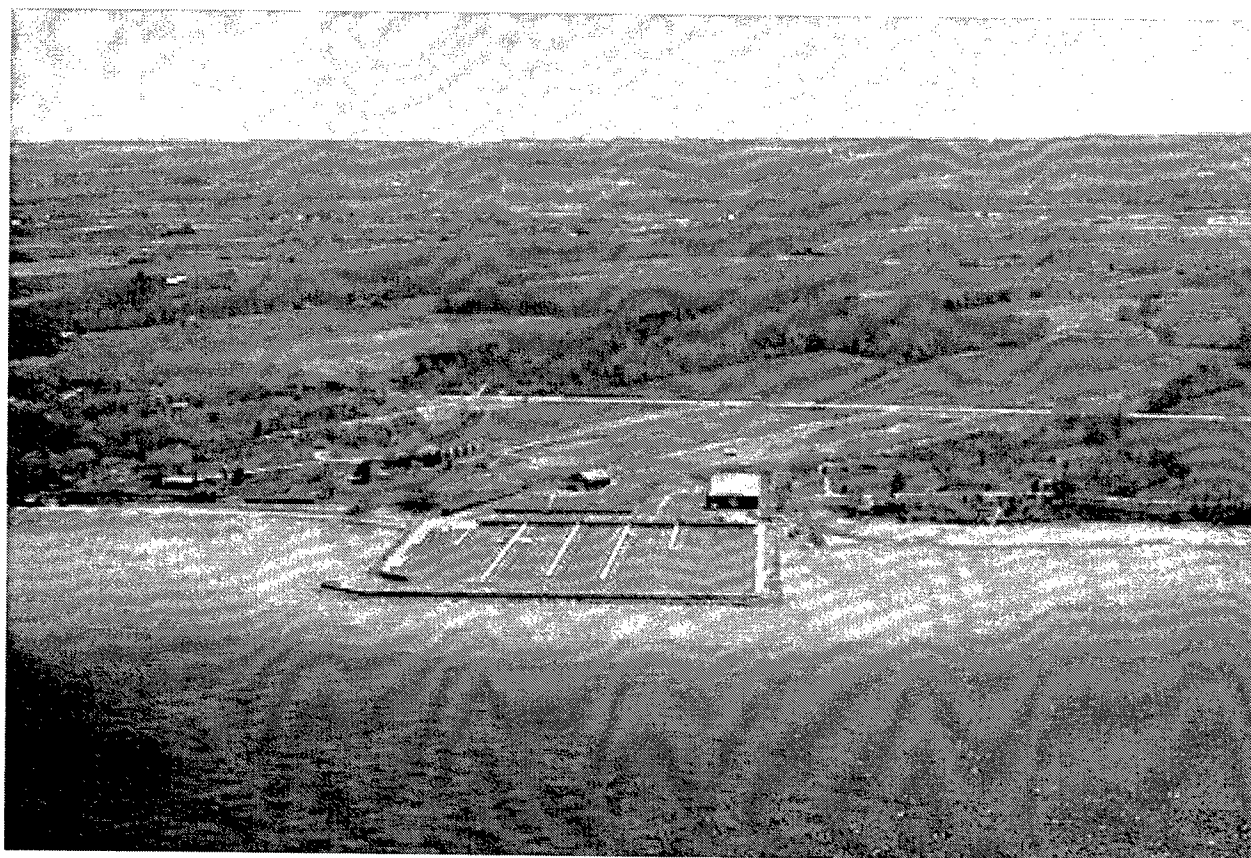
Figure 6. Oblique aerial photograph of marina looking southeast, April 1999. PFBC's spring bypassing operation is in progress, and a backhoe and truck are in the fillet on the right side of the marina. Photograph courtesy Buffalo District

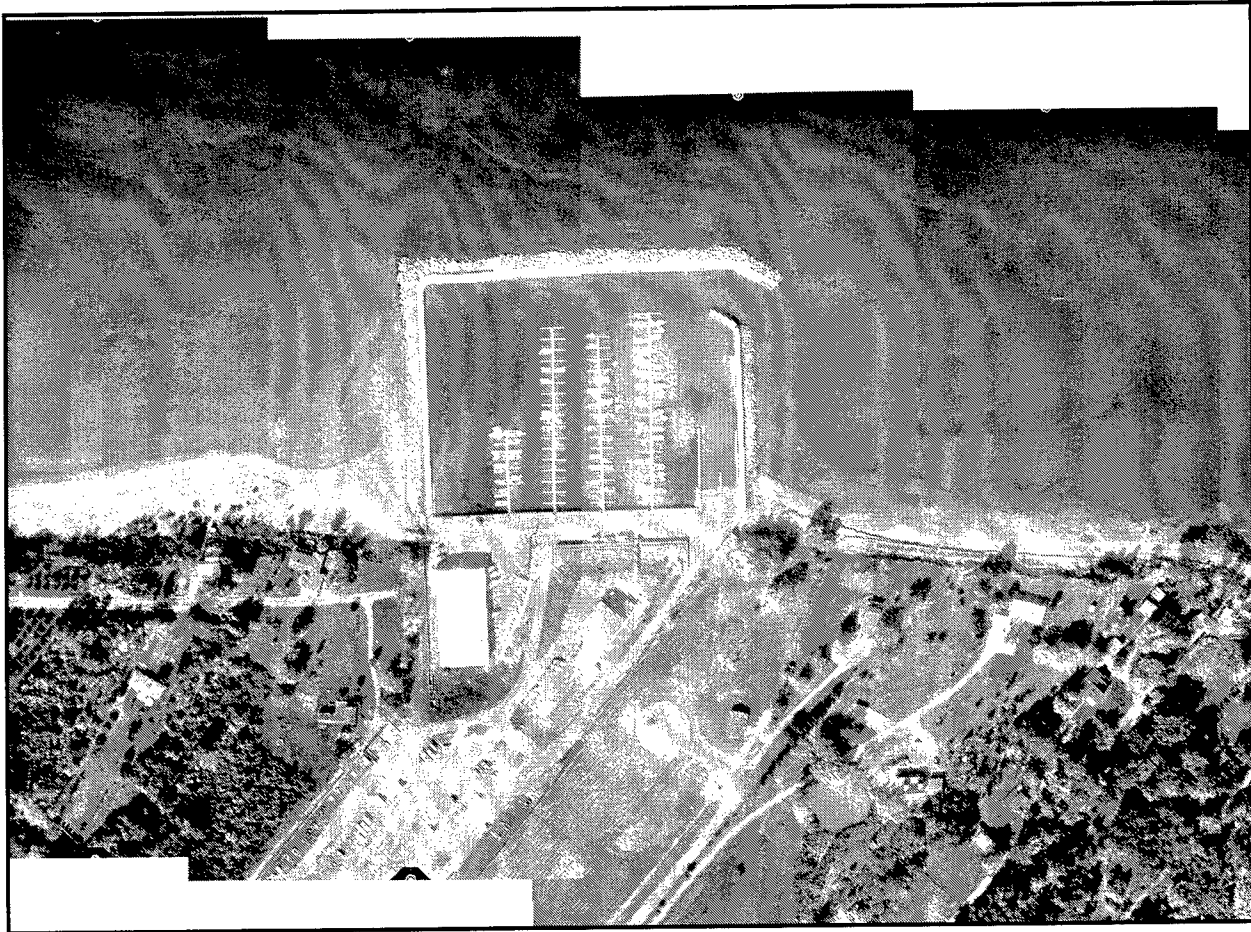
Figure 7. Vertical aerial photograph, October 15, 1999. Shale ledges can be seen through water east (to the right) and lakeward of marina. Bulge in shore west (left) of the marina is accretion on private property that PFBC is unable to mine during biannual bypassing operations

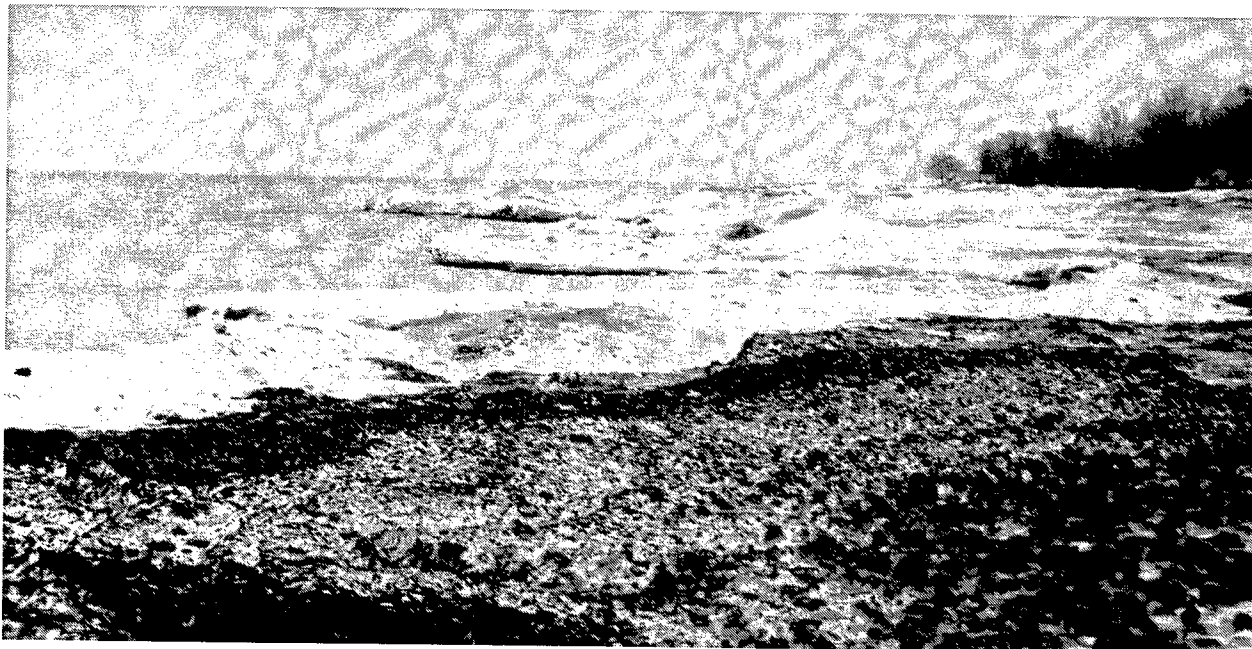
Figure 9. Ice armor along beach, 29 January 1999. During winter, ice protects shore from direct wave attack, but during spring thaw, ice blocks overturn, picking up masses of sand and gravel. View northeast towards Twentymile Creek. Photograph from Buffalo District archives

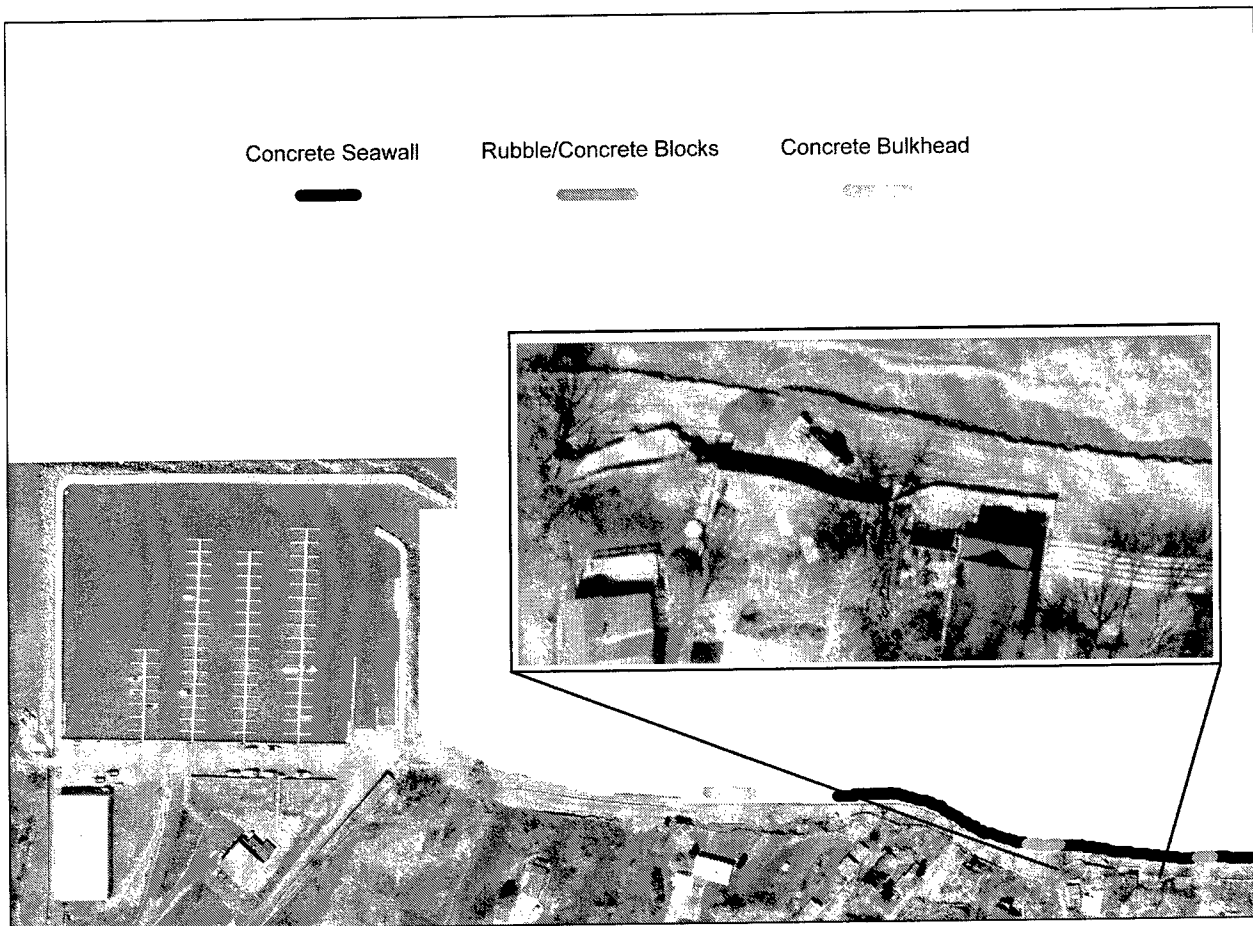
Figure 16. Armoring structures along the shore east of North East Marina (28 April 1999). All of these structures predate the marina. Insert shows a grader moving sand near one of the seawalls that project out from the bluff line

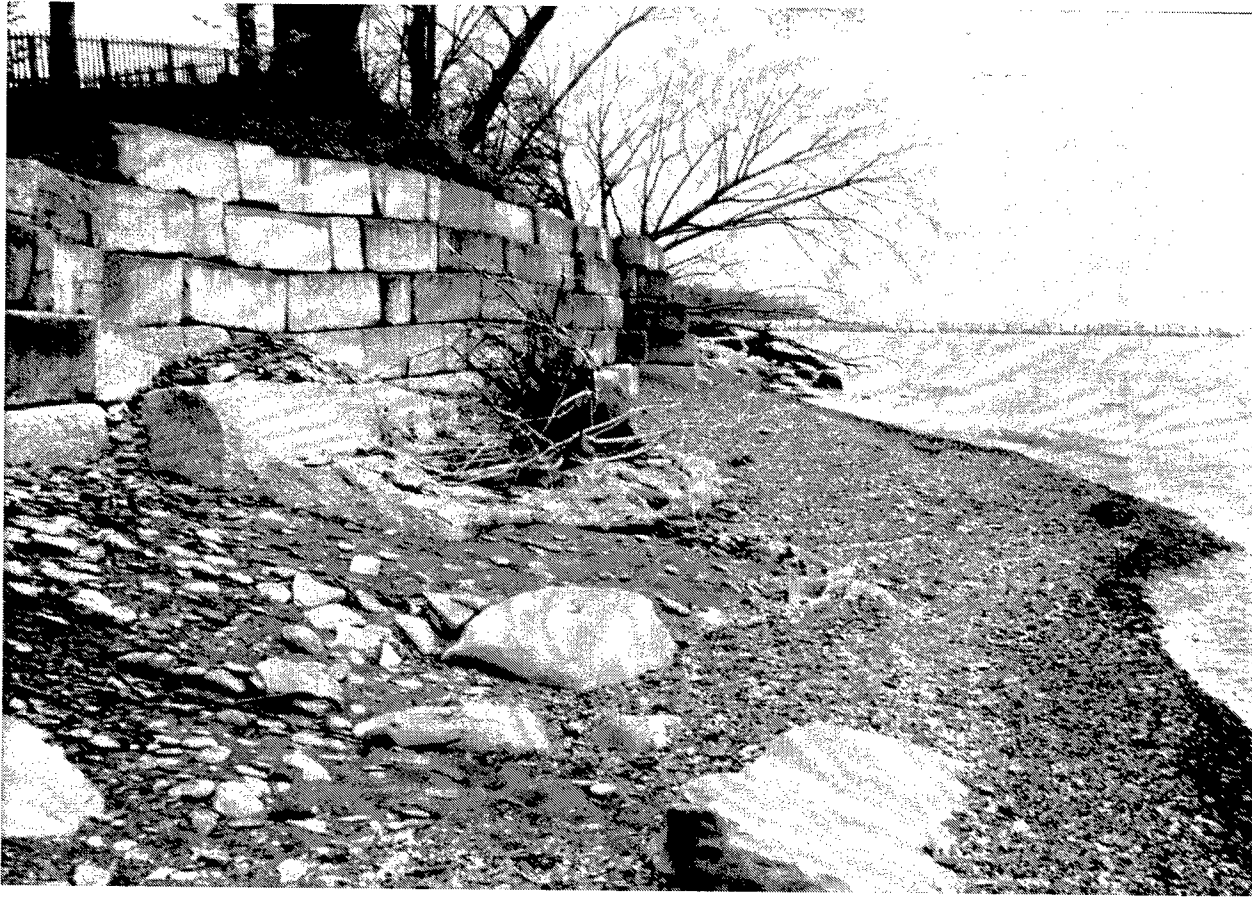
Figure 17. Concrete block wall about 200 m east of marina, 17 May 1991. Leaning tree is seen in subsequent figures

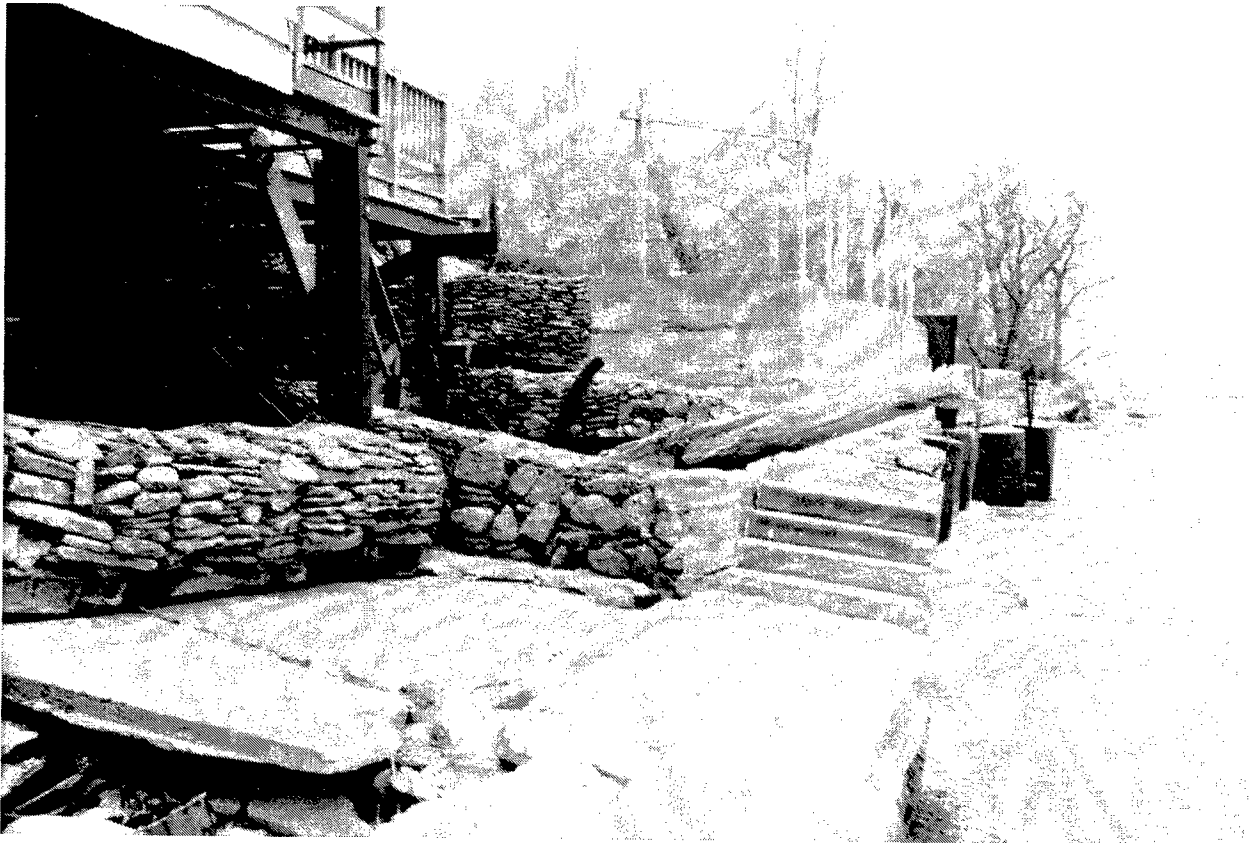
Figure 19. House protected with gabions, concrete, and concrete-filled tanks, May 1991. These structures are about 500 m east of marina's east wall (visible in right side of photograph). Notice tree trunk resting on wall next to steps, evidence of power of storm waves. When this photograph was taken, there was no beach at base of concrete slabs. Photograph from Buffalo District archives

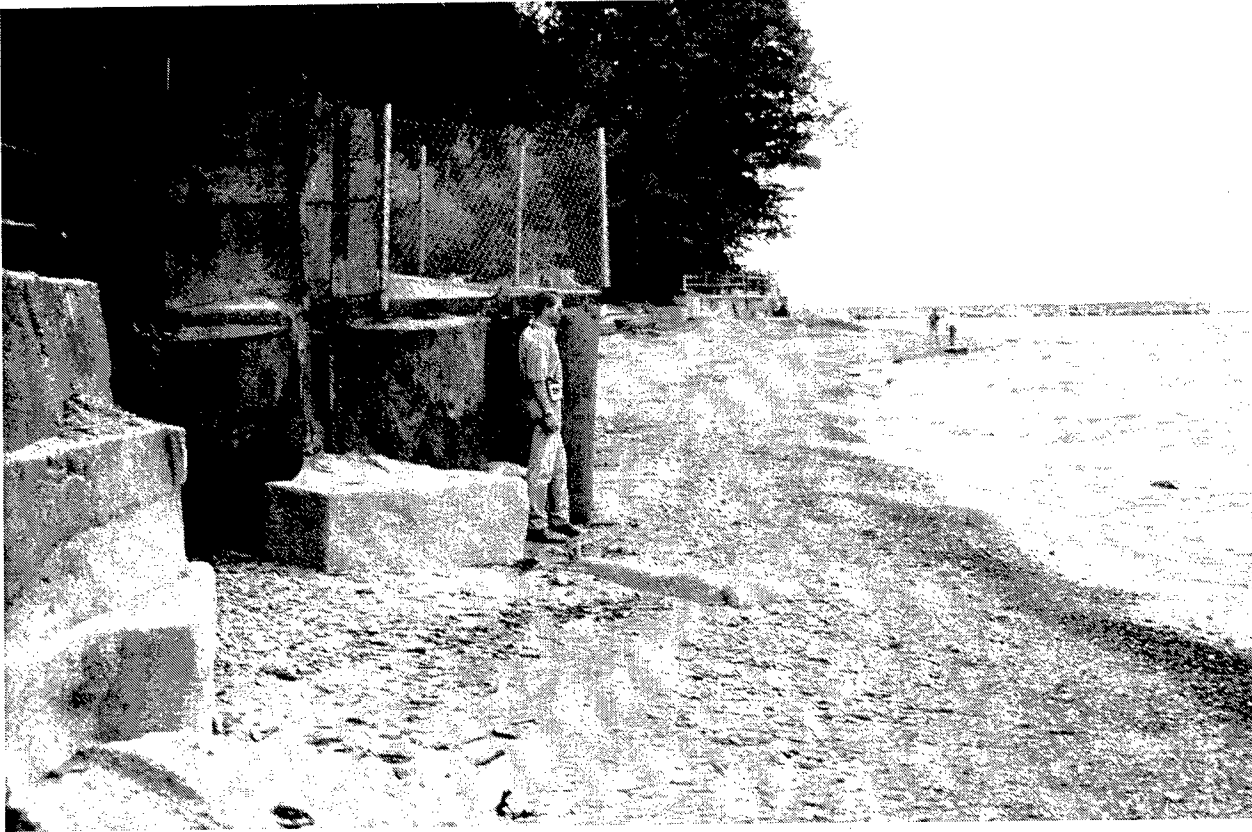
Figure 20. Gravel and sand beach below same structures shown in Figure 19. Beach is about 4 m wide. North East Marina east wall is in distance to right. Photograph taken 11 August 1999, before the autumn bypassing

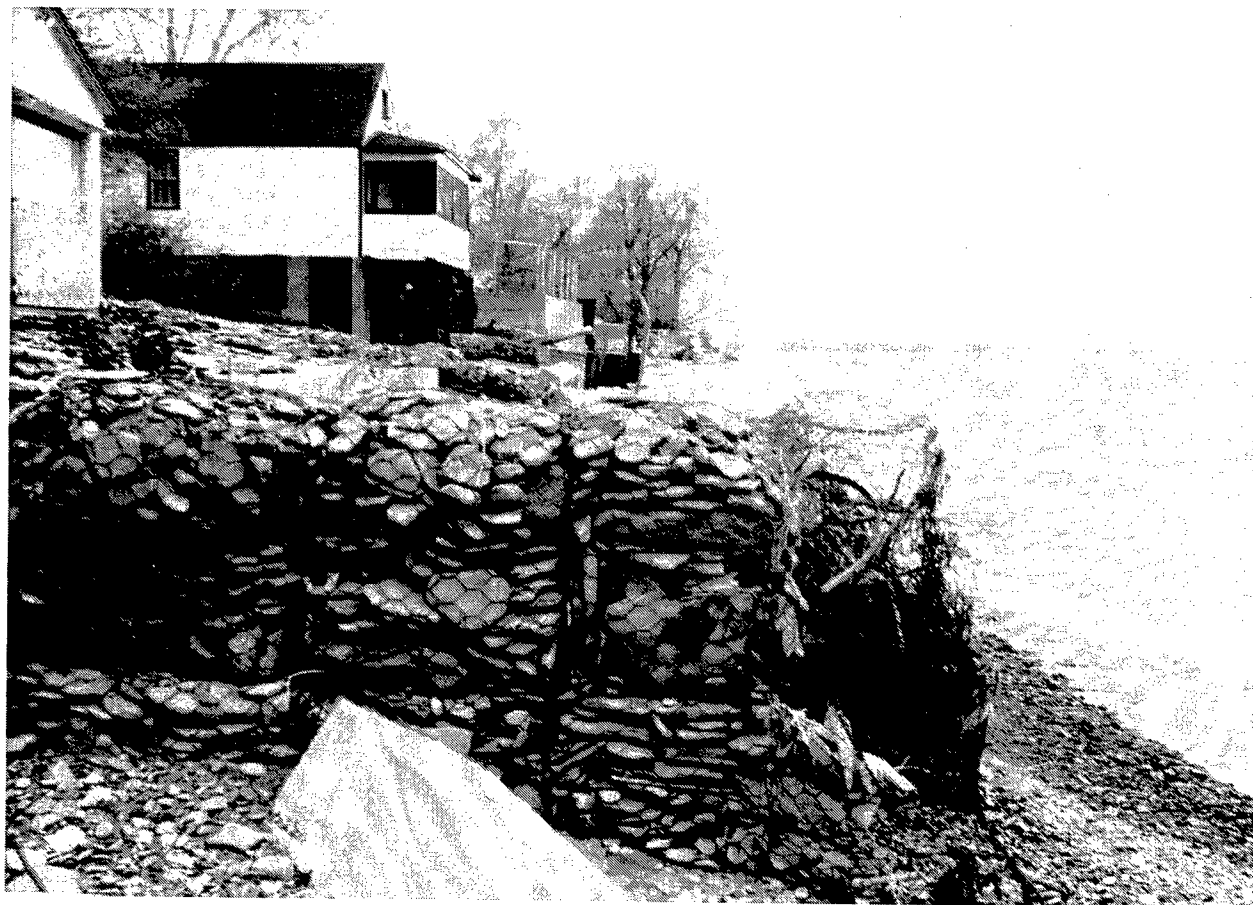
Figure 21. Gabion wall east of property shown in previous photographs, 17 May 1991. Leaning tree where concrete block walls are found is in distance. Photograph from Buffalo District archives

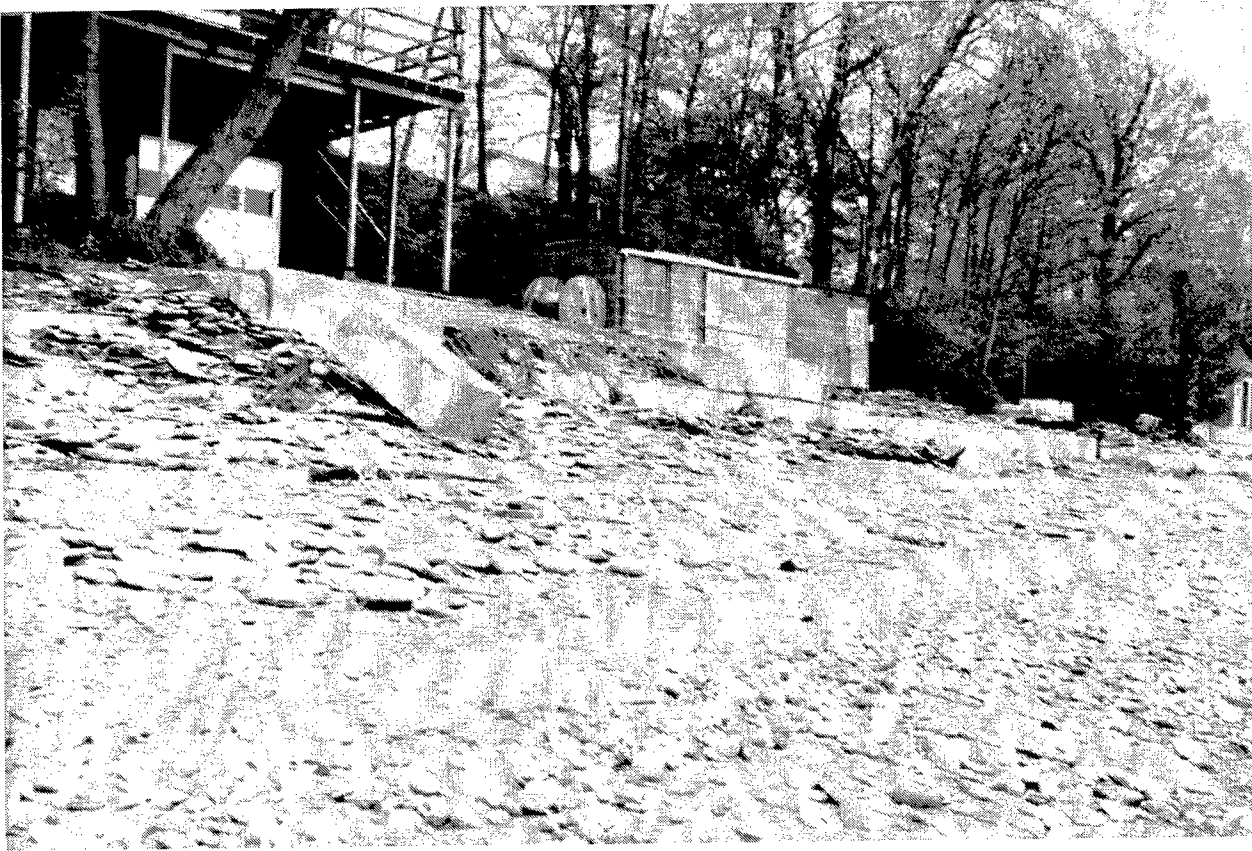
Figure 22. Cottage with protective concrete blocks east of the location shown in previous figures, 17 May 1991. Note the block that has been moved by storm waves. The three properties in the foreground are vulnerable to storm waves because they were built on the beach rather than up on the bluff like the house in the background. Photograph from Buffalo District archives

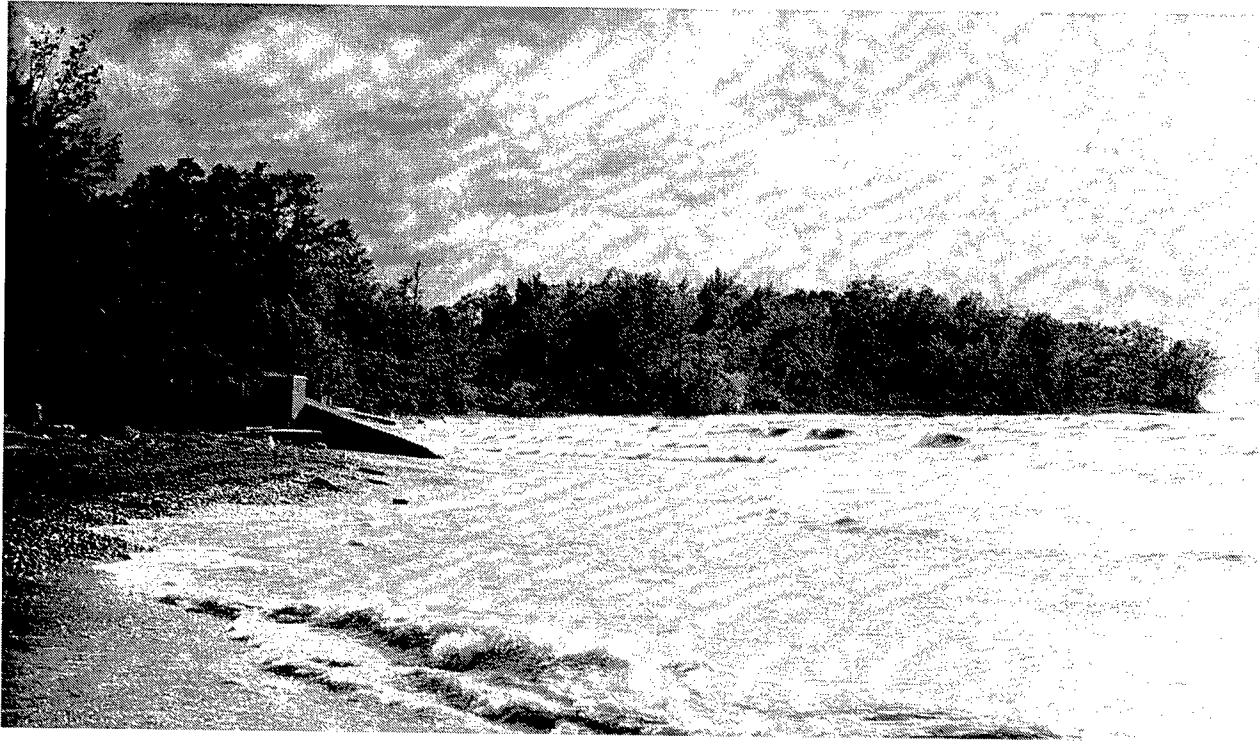
Figure 23. Seawall made of concrete-filled tanks west of North East Marina, November 1991. Most of the ramp and over two thirds of wall are now covered with sand and gravel. In 1991, beyond the walls, there was essentially no beach and waves broke directly at base of bluffs
